NATIONAL ADVISORY COMMITTEE FOR AERONAUTICS

TECHNICAL NOTE

No. 936

PLASTIC MOUNTINGS FOR AIRCRAFT WINDSHIELDS

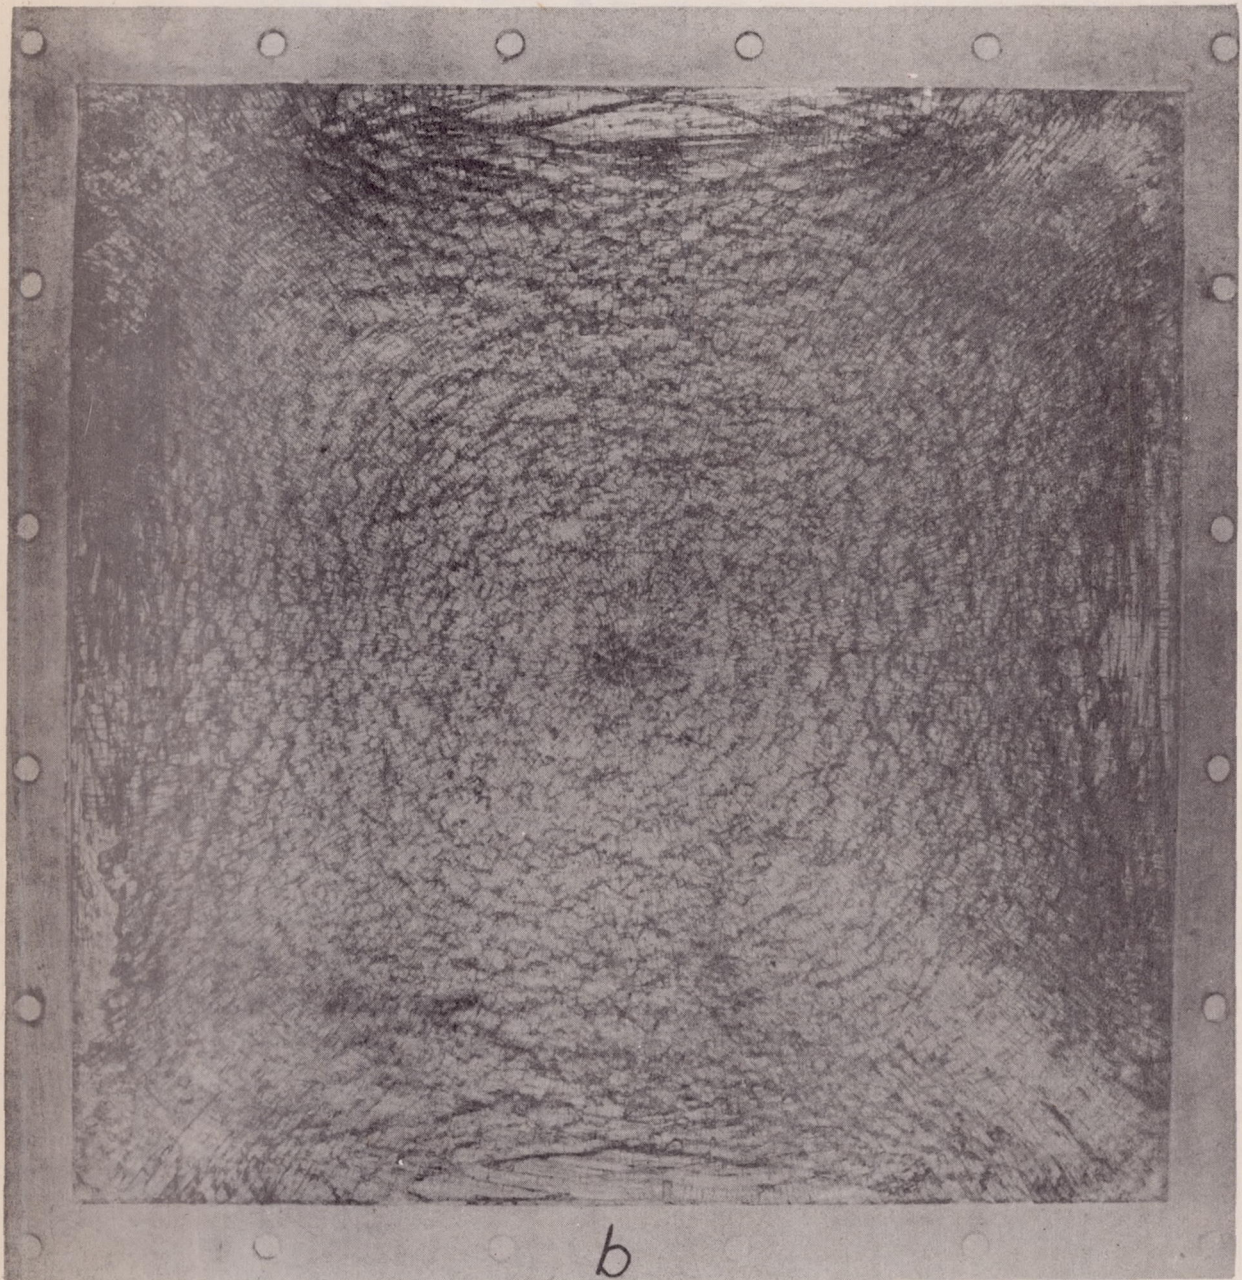
The bursting pressure for the type A panels in the short-time test varied from 10 pounds per square inch at 140° F to 64 pounds per square inch at -20° F. (See table V.) At the higher temperature the panel failed by a combination of shearing and tearing of the plastic around the edges rather than by fracture of the glass. The B type panel, which was somewhat stronger at the high temperature but not at the sub-zero temperature, failed over a pressure range of 20 to 34 pounds per square inch. The C and D panels are much alike in construction and are superior to the others in bursting strength. They failed at pressures ranging from 20 pounds per square inch at 140° F to 70 pounds per square inch at -20° F. At 77° F these two types were characterized by a failure of the glass at about 30 pounds per square inch followed by a failure of the plastic at slightly higher pressure. Types C and D panels deflected greatly after the glass failed at 77° and 140° F; a typical failure from a test made at 77° F is shown in figure 23.

Figure 19.- Type A panel after bursting test at 77°F.

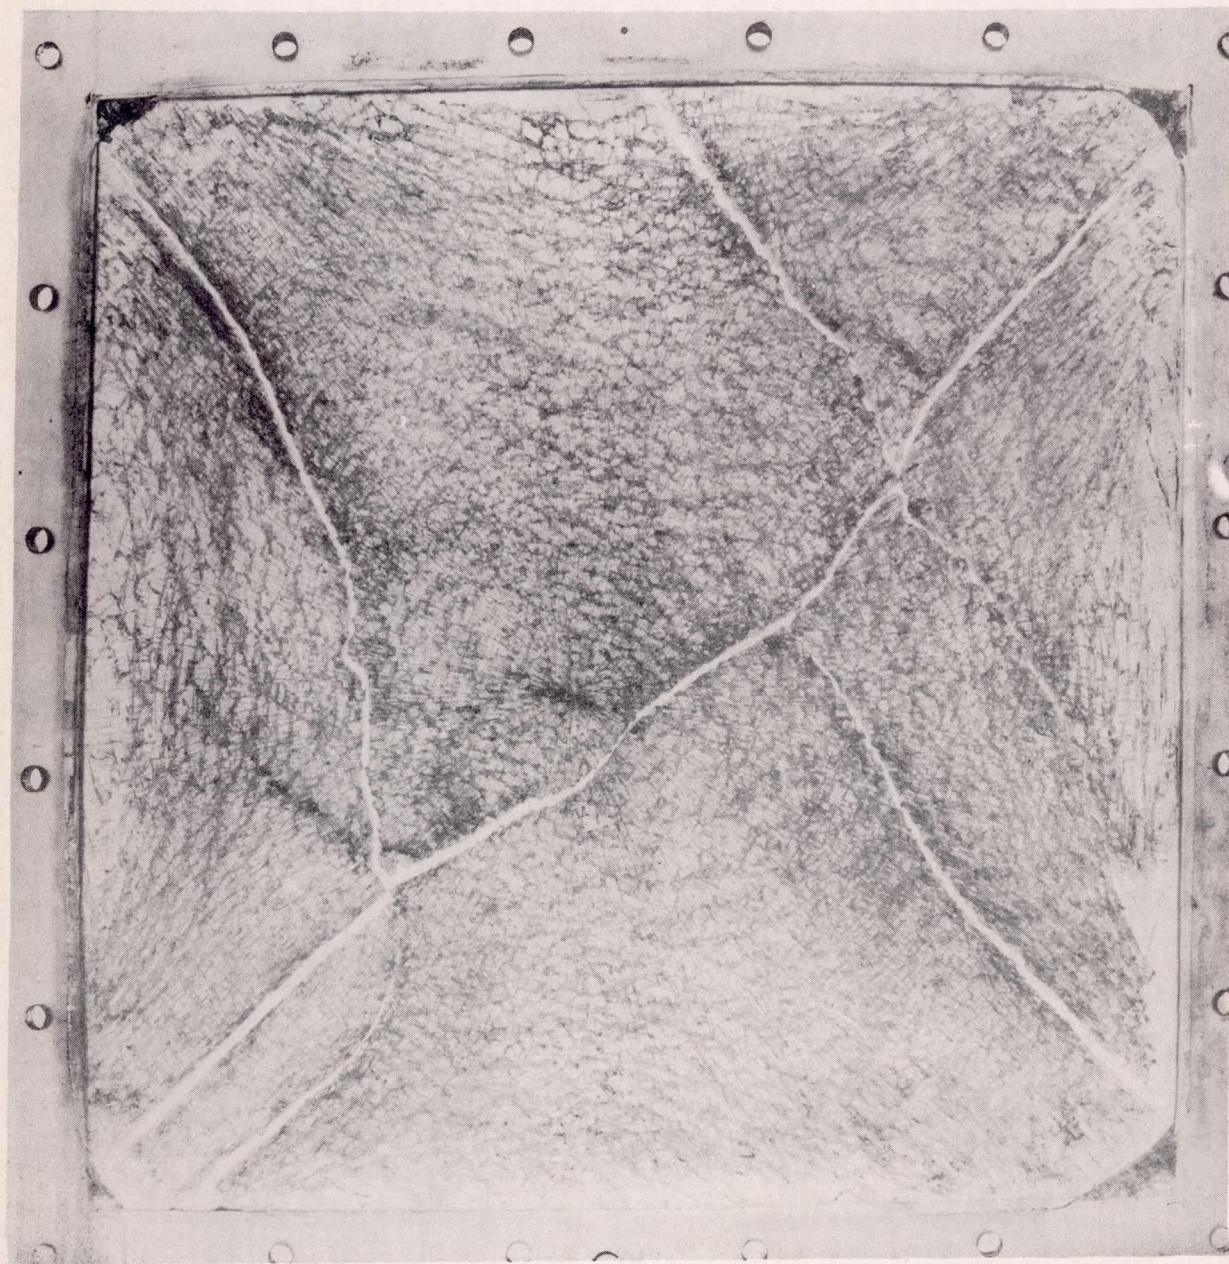
Figure 20.- Type A panel after bursting test at -20°F .

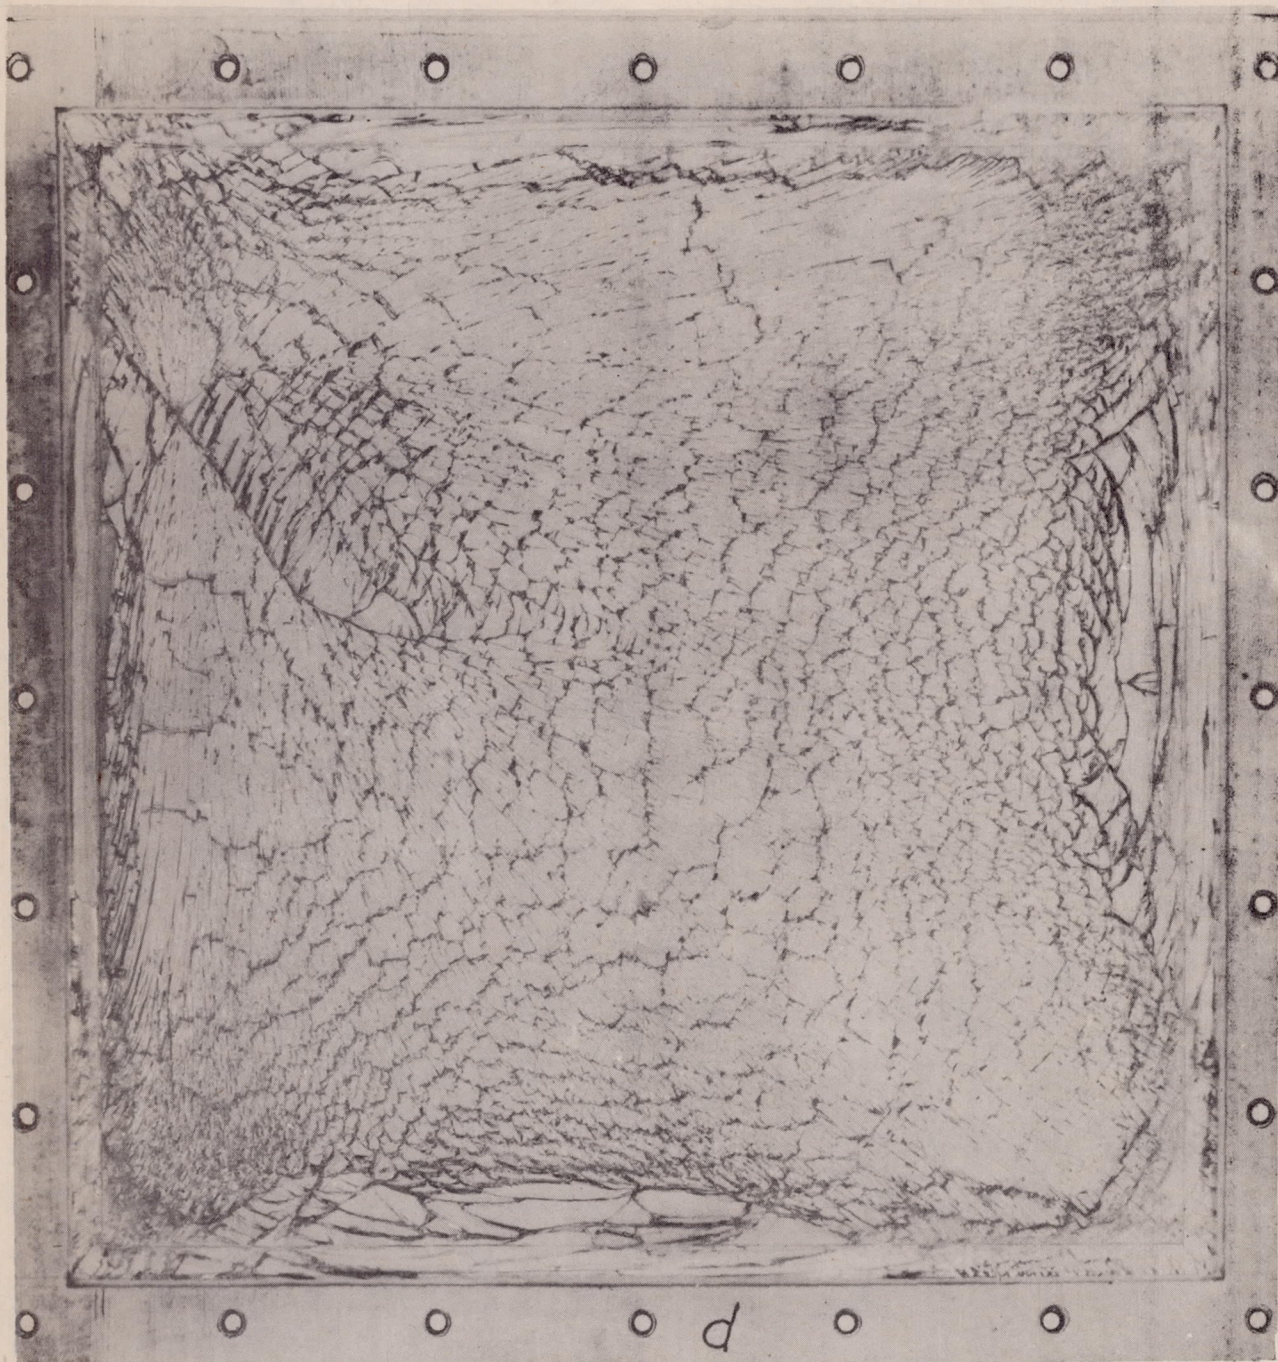
Figure 21.- Type B panel after bursting test at 140°F.

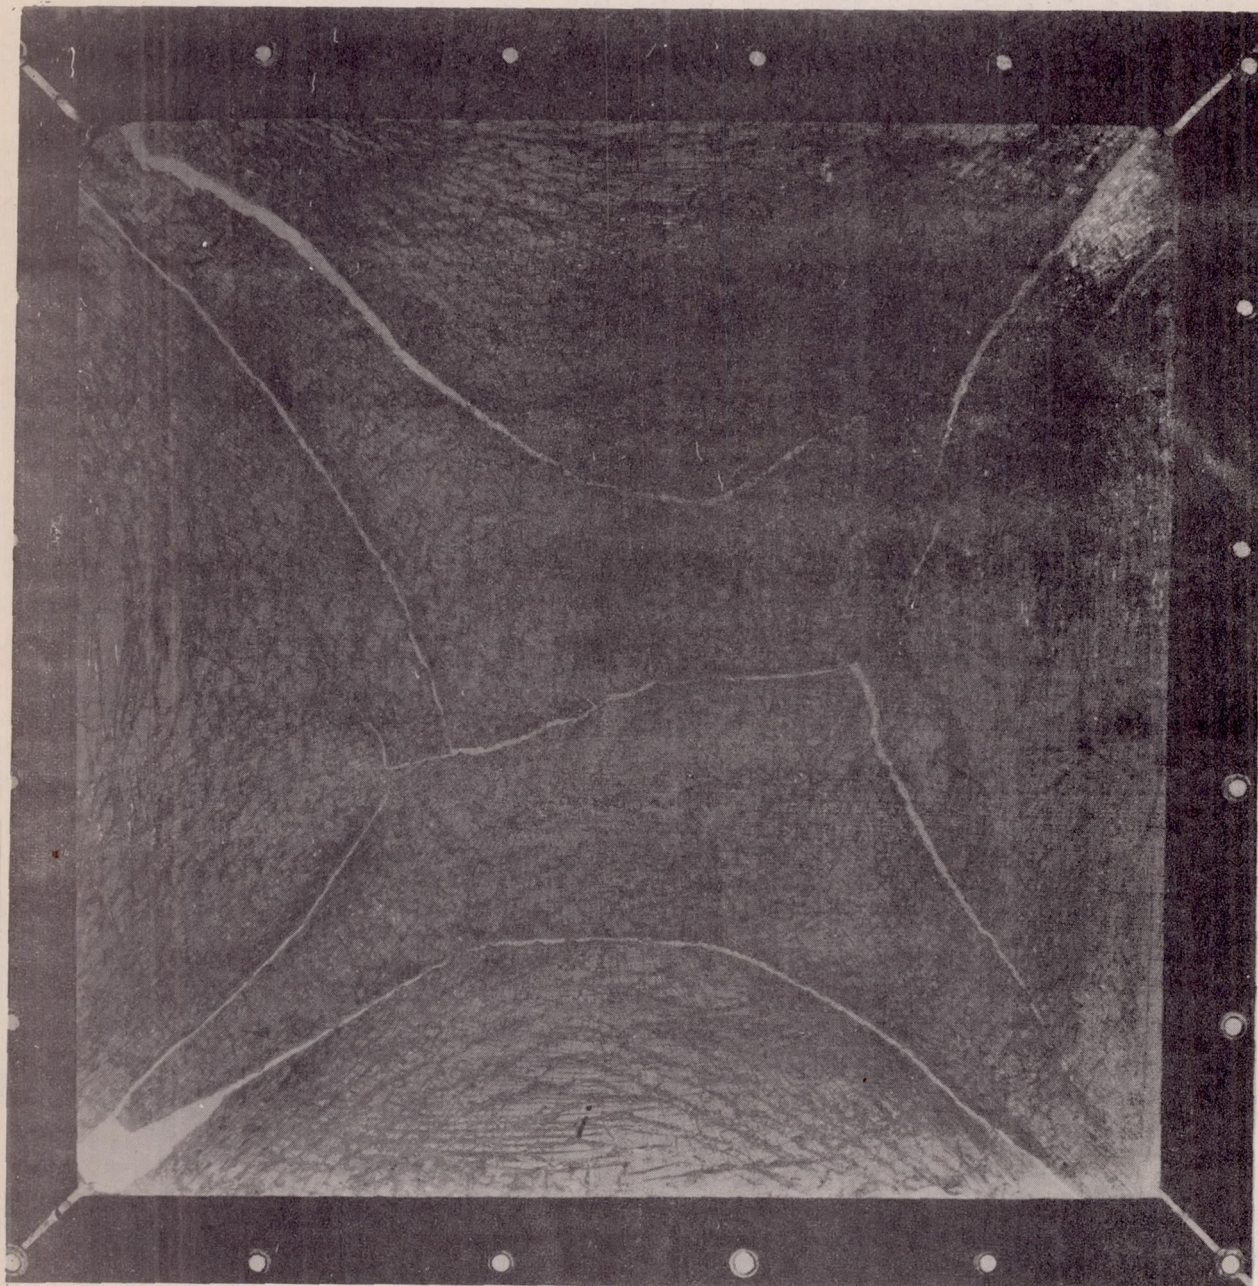
Figure 22.- Type C panel after bursting test at -200°F .

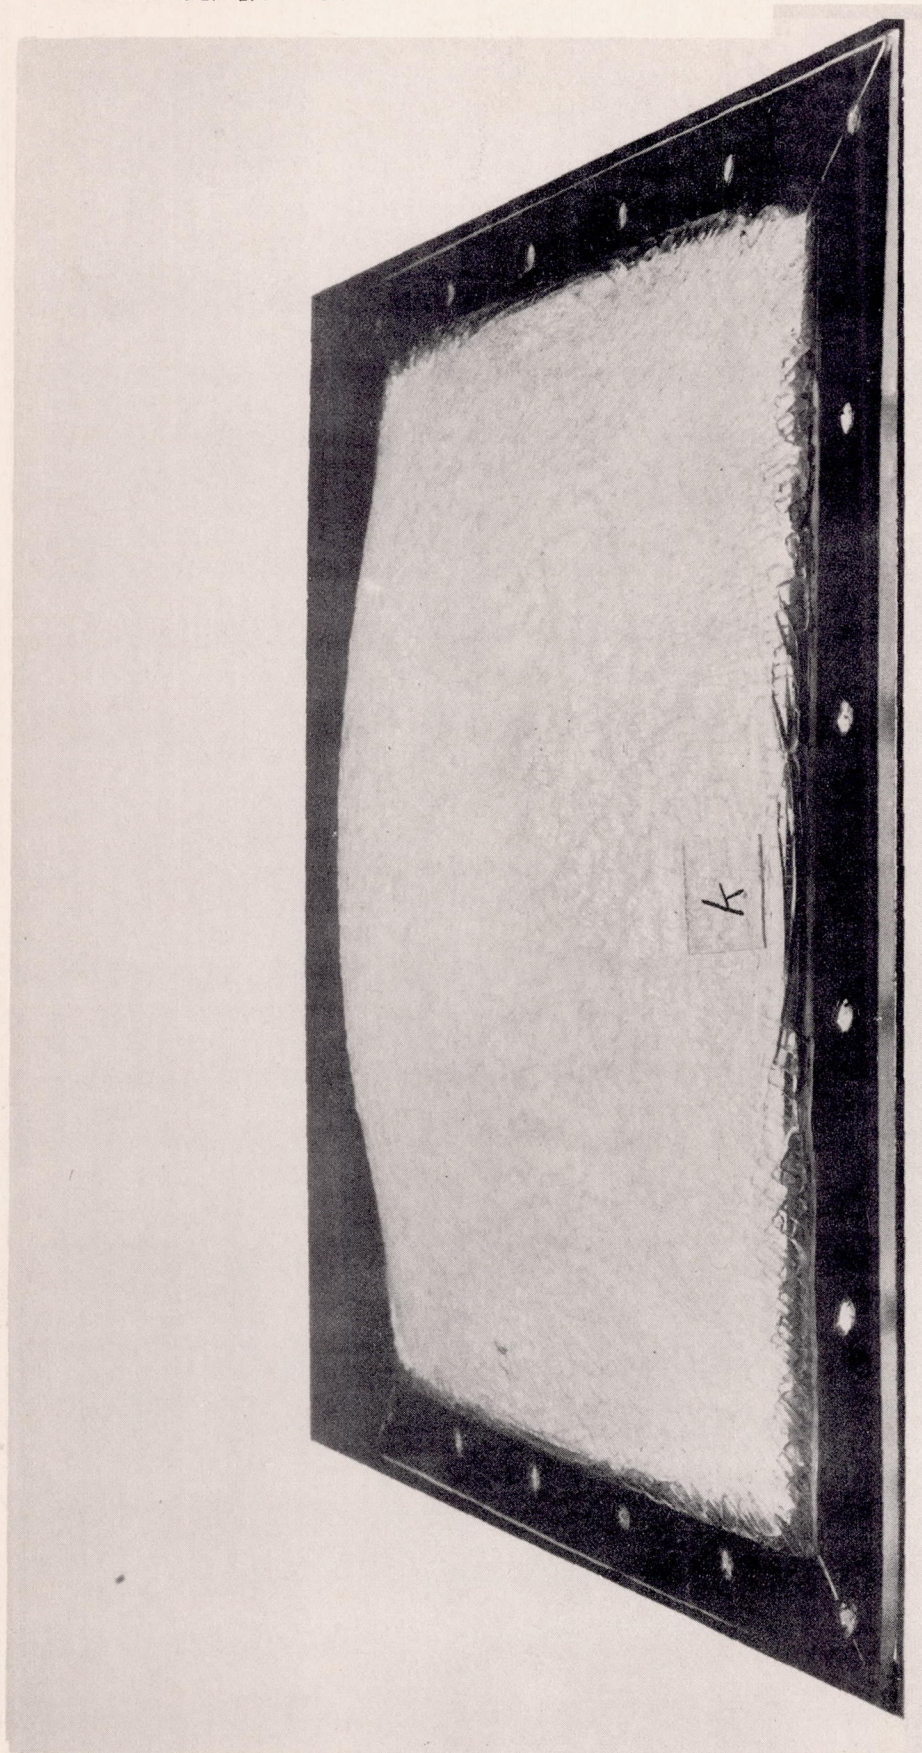
Figure 23. - Type D panel after bursting test at 77°F.
